BATESVILLE PIKE ROAD SAFETY AUDIT FINDINGS REPORT

July 2025

FINAL REPORT

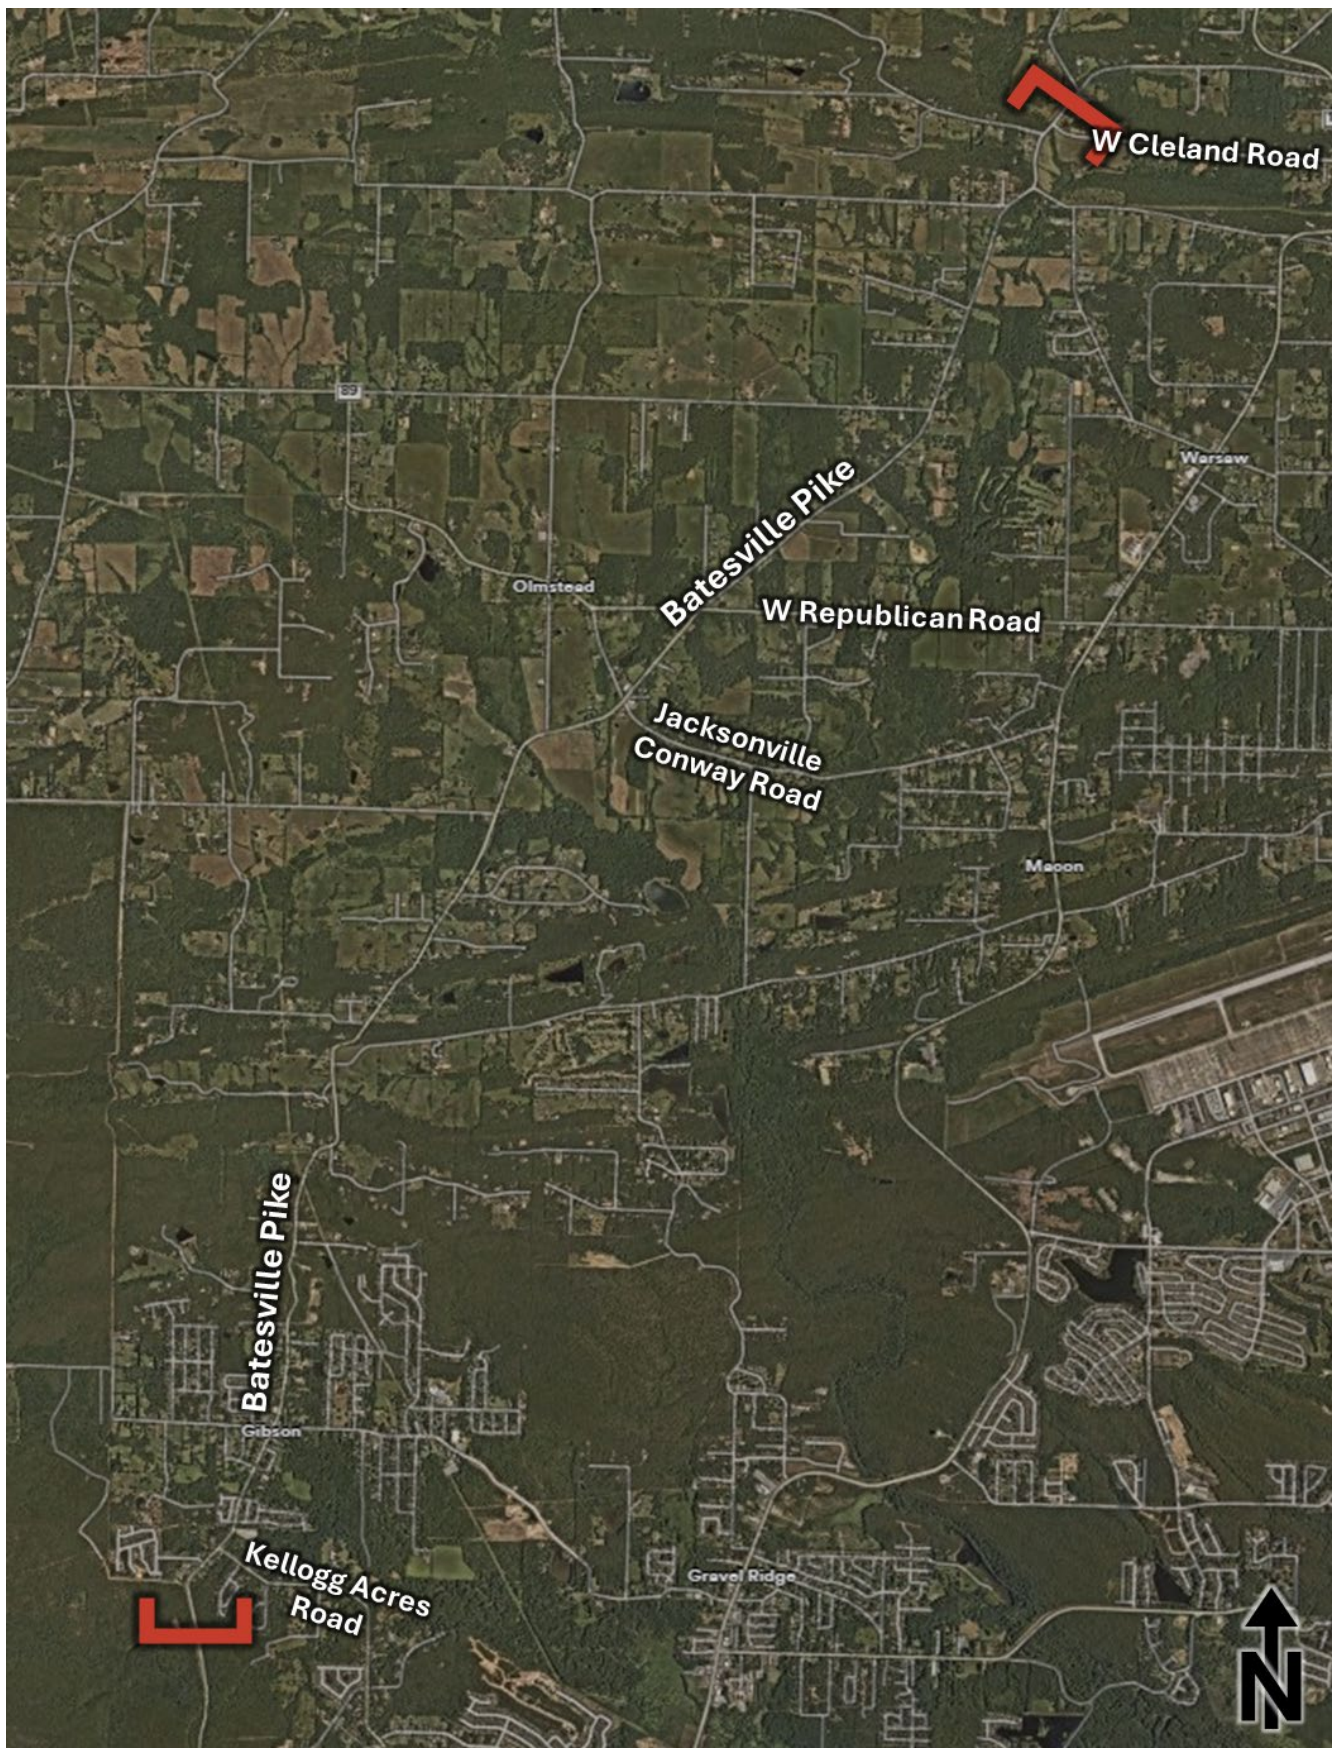
Figure 2: Batesville Pike Study Corridor Extents

Batesville Pike generally runs in the north-south direction, as shown in **Figure 2**, and is primarily surrounded by single family housing and small businesses, with some convenience stores located at major intersections. Batesville Pike provides a connection to the City of North Little Rock and State Highway 107. Batesville Pike becomes State Highway 89 east of State Highway 107, which connects to State Highway 5 and Interstate 57 in the City of Cabot.

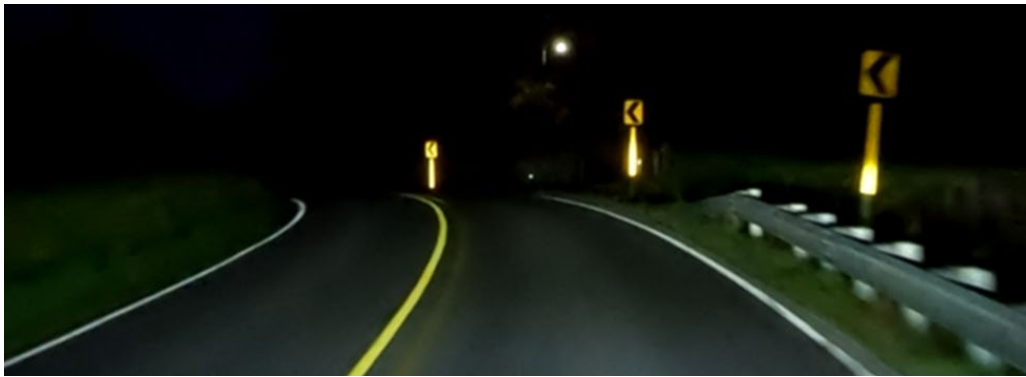
Figure 3: Retroreflective Chevrons at Night

Almost all the roadway signage observed during the nighttime field review was retroreflective and easy to see. Several signs, primarily chevron and stop signs, had retroreflective tape on the sign posts to further increase driver awareness of the signs. Retroreflective roadway signage is essential for nighttime sign visibility, particularly along rural corridors with limited or no corridor lighting. An example of retroreflective chevron signs with

retroreflective tape on the posts along Batesville Pike for southbound vehicles approaching the curve near Old Tom Box Road is shown at night in **Figure 3**.

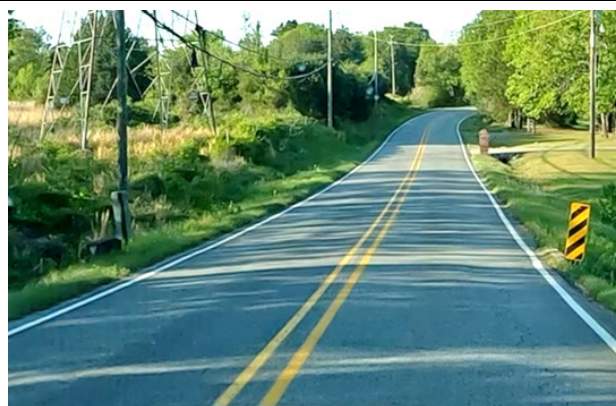
- Many of the culverts and bridges on Batesville Pike have objects on the right side of the road but not the left side, and several were missing object markers on both sides.
- Many of the mailboxes are also missing object markers.

Figure 5: Object markers only on the right side of a culvert in both directions on Batesville Pike between Northview Road and Angel Lane.

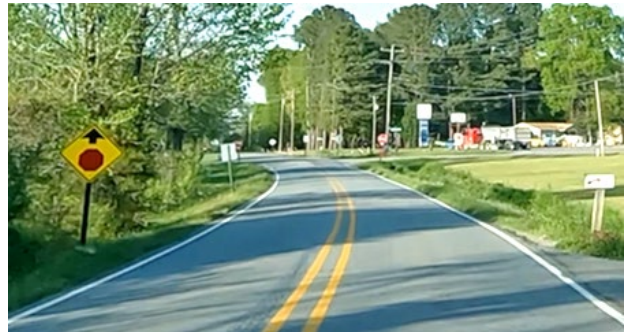
Figure 6: Stop ahead warning sign only exists on the left side of the northbound approach of Batesville Pike to Jacksonville Conway, but signs are double posted for the other three approaches to the intersection.

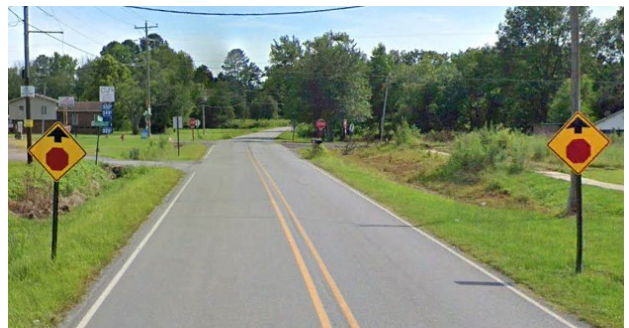
Figure 7: Stop ahead warning signs are double posted for the southbound approach of Batesville Pike to Jacksonville Conway and signs are located approximately 180-feet in advance of the intersection.

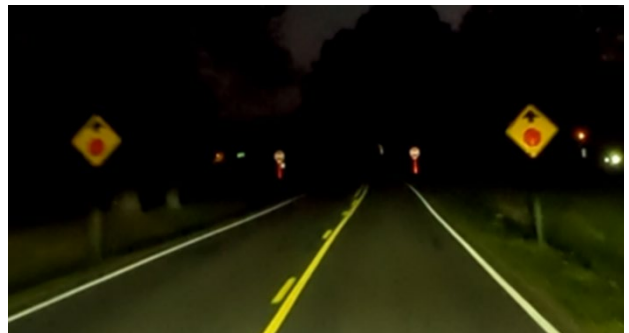
Figure 8: Double posted stop ahead warning signs and stop signs with red reflective tape on the sign posts located at the southbound approach of Batesville Pike to Republican Road.

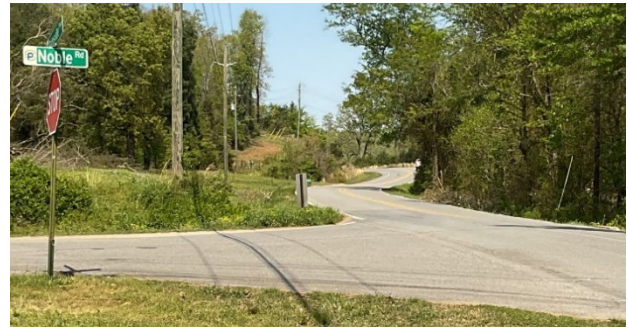
Figure 9: Intersection within curve near where no warning signs exist in advance of the intersection.

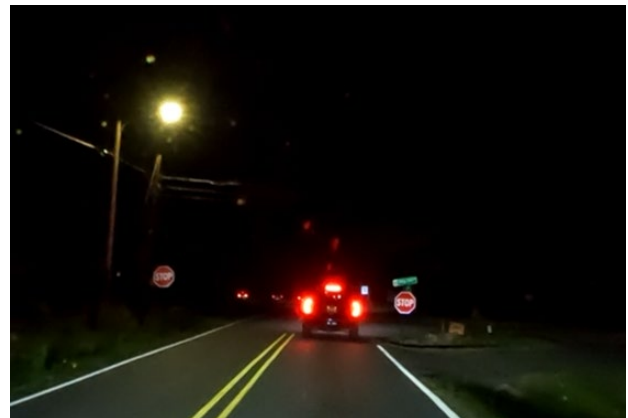
Figure 10: Intersection of Batesville Pike and Kellogg Acres Road with some lighting present.

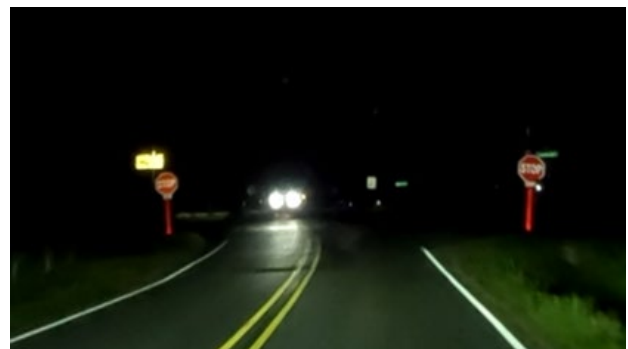
Figure 11: Intersection of Batesville Pike and Jacksonville Conway with no intersection lighting present.

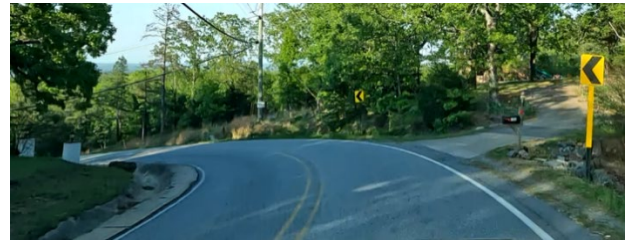
Figure 12: Chevron signs do not continue through the entire curve for vehicles on northbound Batesville Pike at the 90-degree curve near Northview Road.

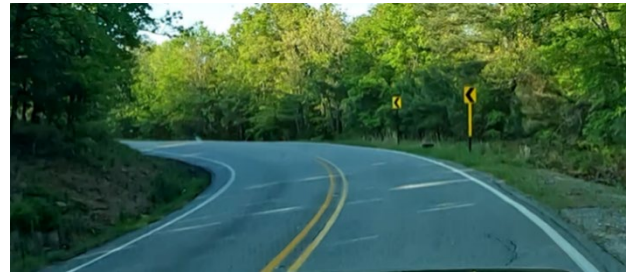
Figure 13: Chevron signs do not continue through the entire curve for northbound vehicles on Batesville Pike at the 'S' curve between Angel Lane and Greer Road.

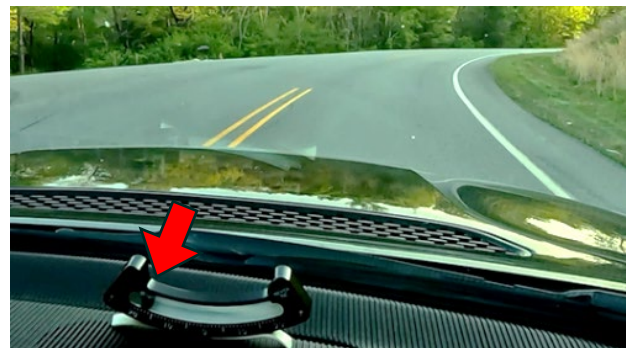
Figure 14: RSA team's ball bank indicator maxed out at 19 while driving southbound on Batesville Pike at 35 mph around the curve north of Greer Road.

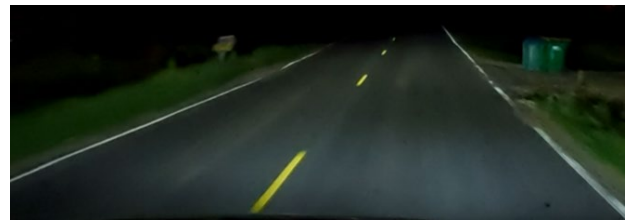
Figure 15: Pavement markings on Batesville Pike at night.

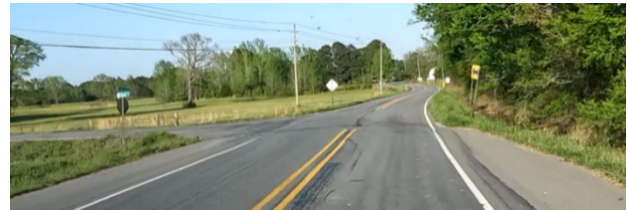
- Batesville Pike north of the RSA study corridor limits has 6-inch striping, centerline rumble strips, raised pavement markers in the center, and about 1 to 2-foot pavement buffers on each side. These features make the road feel safer and it is easier to follow the road during nighttime driving conditions.
- Run off the road crashes are common along Batesville Pike in the study corridor.
- A paved shoulder is not consistently present on both sides of the road along the entire study corridor.

Figure 16: Paved shoulders exist on a section of Batesville Pike south of Fortson Road but not immediately north of Fortson Road.

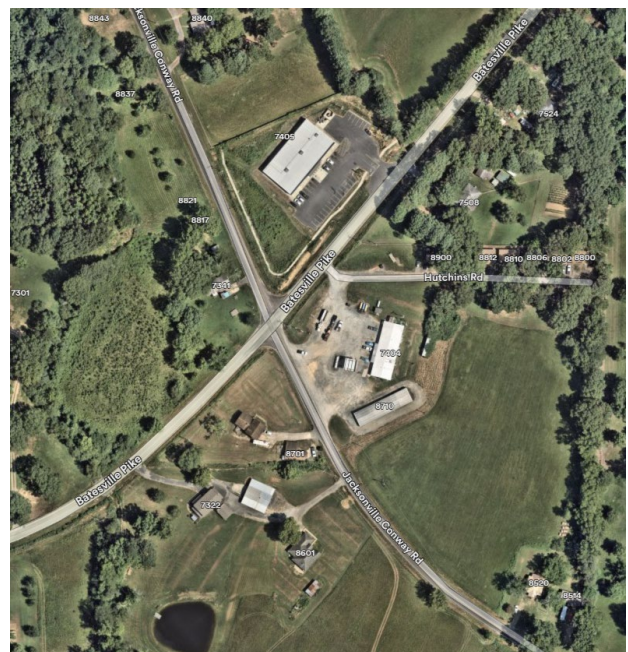
- The intersection of Batesville Pike and Jacksonville Conway Road creates a sharp 'X' with small radius turning movements.
- Pulaski County representatives noted concerns with speeding in this area and a desire to implement traffic calming countermeasures.

Figure 17: Aerial view of the Batesville Pike and Jacksonville Conway Road intersection.

- Replace the stop-controlled intersection with a roundabout.

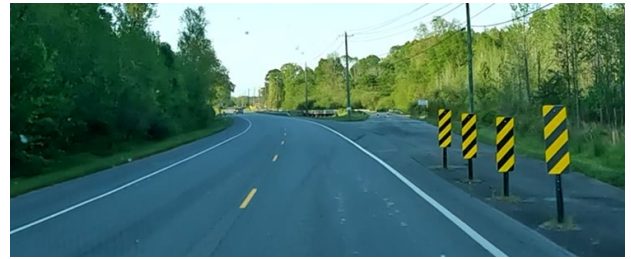
Figure 18: Object markers posted along the northbound approach of Batesville Pike to the decommissioned bridge alignment, south of Frenchman Mountain Road.

- Extend object markers or install delineators along the entire edge of Batesville Pike where the pavement connects to the decommissioned bridge alignment. Replace road closed signs with larger ones to enhance visibility for approaching drivers, especially on the northbound approach.

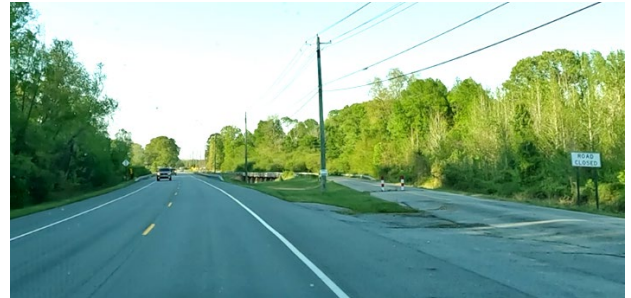
Figure 19: Northbound approach of Batesville Pike realignment to the decommissioned bridge.

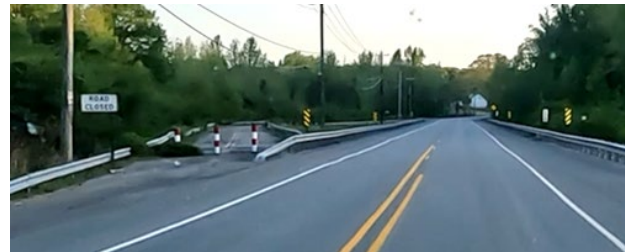
Figure 20: Southbound approach of Batesville Pike realignment to the decommissioned bridge.

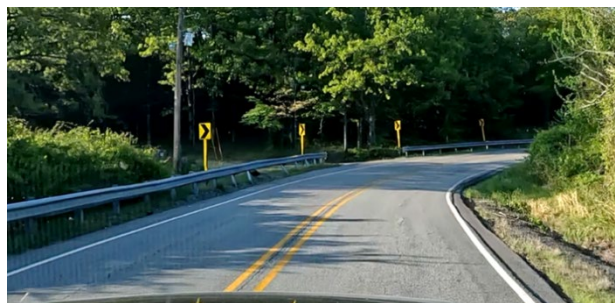
Figure 21: Northbound approach 90-degree curve near Old Tom Box Road with a break in the guardrail at the apex of the curve.

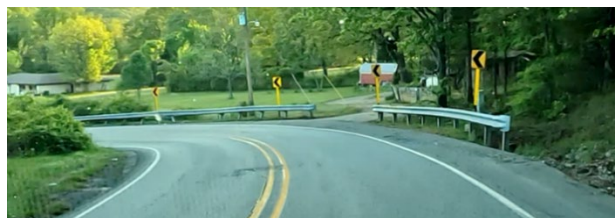
Figure 22: Southbound downhill approach to 90-degree curve near Old Tom Box Road with a break in the guardrail at the apex of the curve.

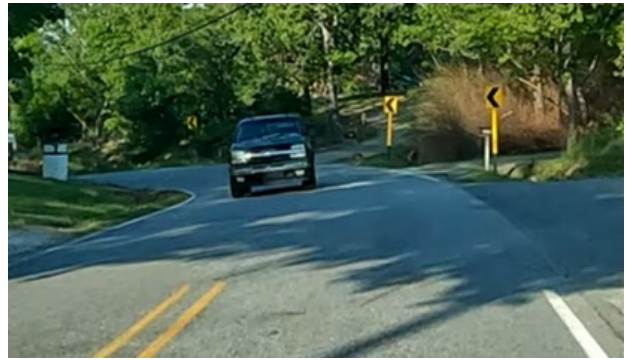
- Southbound vehicles on Batesville Pike were observed veering across the centerline while traveling through the 90-degree curve near Northview Road. The veering may be due to speeding despite it being 12% grade uphill and narrow lanes with a ditch on either side. Drivers may be trying to maintain speed up the hill through the curve and the ditch on the inside of the curve may make drivers swing wide through the turn to avoid getting too close to the edge of pavement.

Figure 23: Southbound vehicle on Batesville Pike veering across the centerline while traveling through the 90-degree curve near Northview Road.

- Corridor-wide recommendation No. 6 regarding wider striping, rumble strips, and shoulders would likely address the issue with southbound vehicles veering across the centerline noted above. Centerline rumble strips at this location can alert a driver who is crossing the centerline and a paved buffer at the shoulder may make drivers feel more comfortable staying close to the inside of the curve.

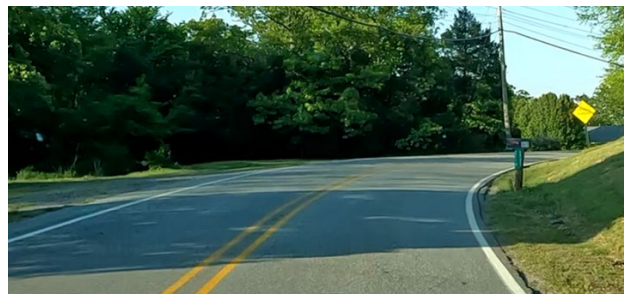
- Chevron signs do not exist along the less severe curve at the northbound approach to a 90-degree curve just south of Northview Road.
- A curve warning sign for northbound vehicles has an advisory speed of 15 mph which seemed to be an excessively slow speed for the curve (RSA team members drove this curve as 25 mph which felt very comfortable). Advisory speeds that are too low could cause drivers to ignore other advisory speeds along the corridor.

Figure 24: Chevron signs do not exist along the less severe curve at the northbound approach to a 90-degree curve just south of Northview Road.

- Corridor-wide recommendation No. 5 regarding curve warning signage on Batesville Pike will address the chevron signing and advisory speed observations noted above.

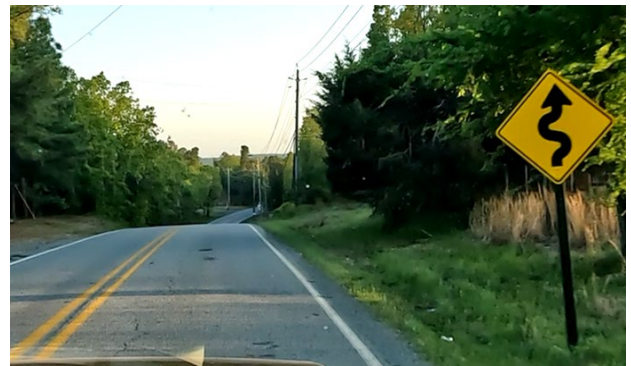
Figure 25: Winding road warning sign on southbound Batesville Pike prior to the series of curves.

- Add NEXT ½ MILE plaque under the southbound winding road warning sign on Batesville Pike.
- Change the left curve warning sign noted above to an 'S' curve with a speed advisory plaque.
- Add a curve warning sign prior to the last southbound left curve in the series of curves.

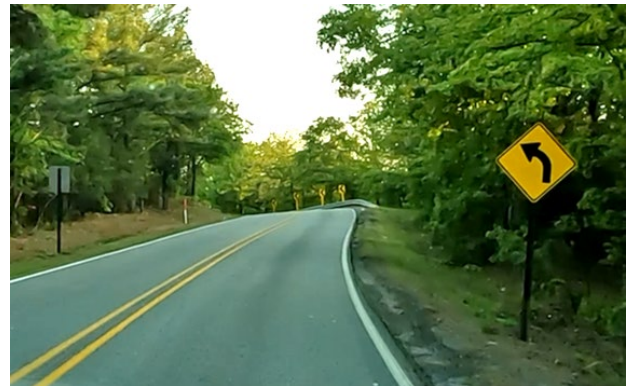
Figure 26: Left curve warning sign on southbound Batesville Pike just south of Angel Lane, however the road is curving right.

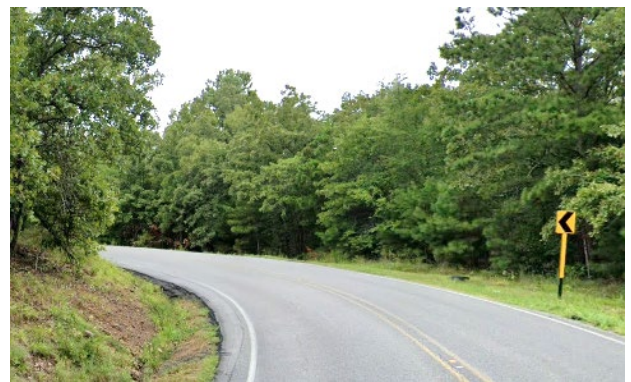
Figure 27: The superelevation on northbound Batesville Pike is sloped towards the outside of the curve at the first left curve north of Greer Road.

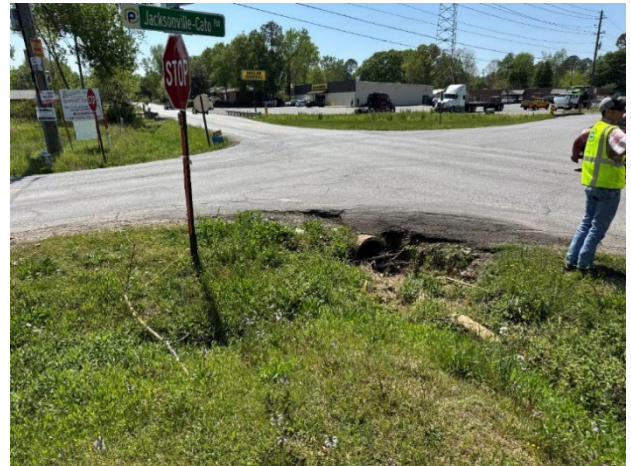
- The right-turn movement from westbound Jacksonville Cato onto northbound Batesville Pike has a very small radius and a steep drop off to a ditch on the inside of the curve.
- Pulaski County has conducted a signal warrant in the past at this location the intersection did not meet signal warrants.
- Pulaski County representatives noted that they would prefer a roundabout at this intersection to reduce crashes at the intersection and reduce speed along Batesville Pike.
- Pulaski County representatives noted that there are several drainage and utility conflicts surrounding the intersection.

Figure 28: Intersection of Batesville Pike and Jacksonville Cato Road with a drainage ditch close to the edge of pavement at the northeast corner.

- Replace the stop-controlled intersection with a roundabout.

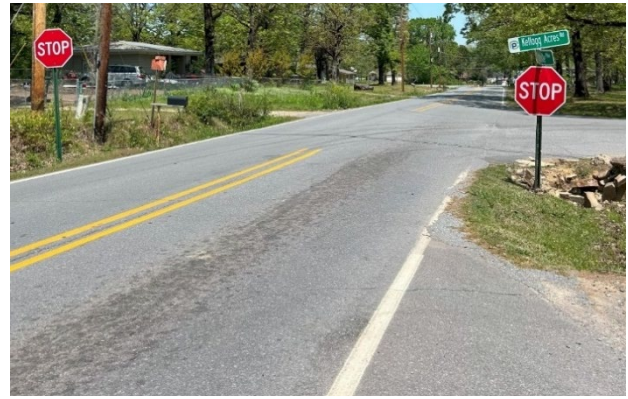
Figure 29: Bottom of existing stop sign at the northbound approach of Batesville Pike to Kellogg Acres Road is posted at 3-feet and 4-inches above the surface of the pavement.

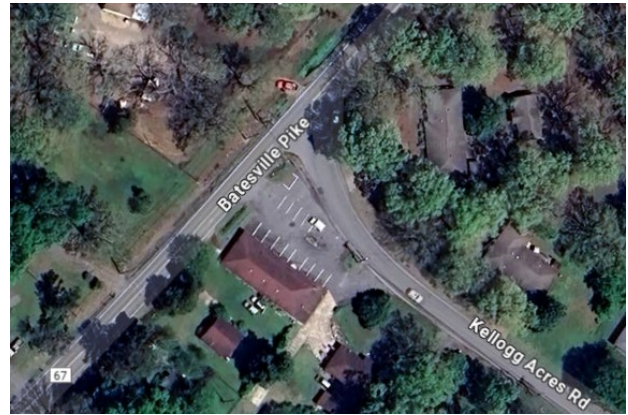
- Northbound vehicles on Batesville Pike turning right onto Kellogg Acres Road were observed stopping then pulling out in front of southbound vehicles on Batesville Pike that were turning left onto Kellogg Acres Road.

- The existing intersection geometry and signage may lead northbound drivers on Batesville Pike, which has a stop sign, to think southbound vehicles on Batesville Pike turning onto Kellogg Acres Road also should stop. Although there were no fatal or serious injury crashes recorded during the five-year study period, the RSA team noted this intersection appears to have a high potential for a fatal or serious injury crash.

Figure 32: Batesville Pike/Kellogg Acres Road intersection.

- Realign the northbound approach of Batesville Pike to curve east and intersect the curve of Batesville Pike/Kellogg Acres Road near the apex of the curve. Add curb and gutter as shown in the concept in **Appendix C**. This option will better clarify to northbound drivers on Batesville Pike that they are the minor approach and the only vehicles that stop. *Note: This improvement should only be considered if the mid-term suggested improvements cannot be implemented in a timely manner.*

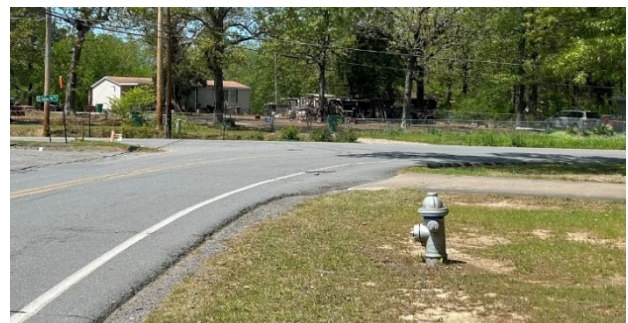
Figure 33: Kellogg Acres Road centerline stripe is curved to guide westbound vehicles approaching Batesville Pike to turn right.

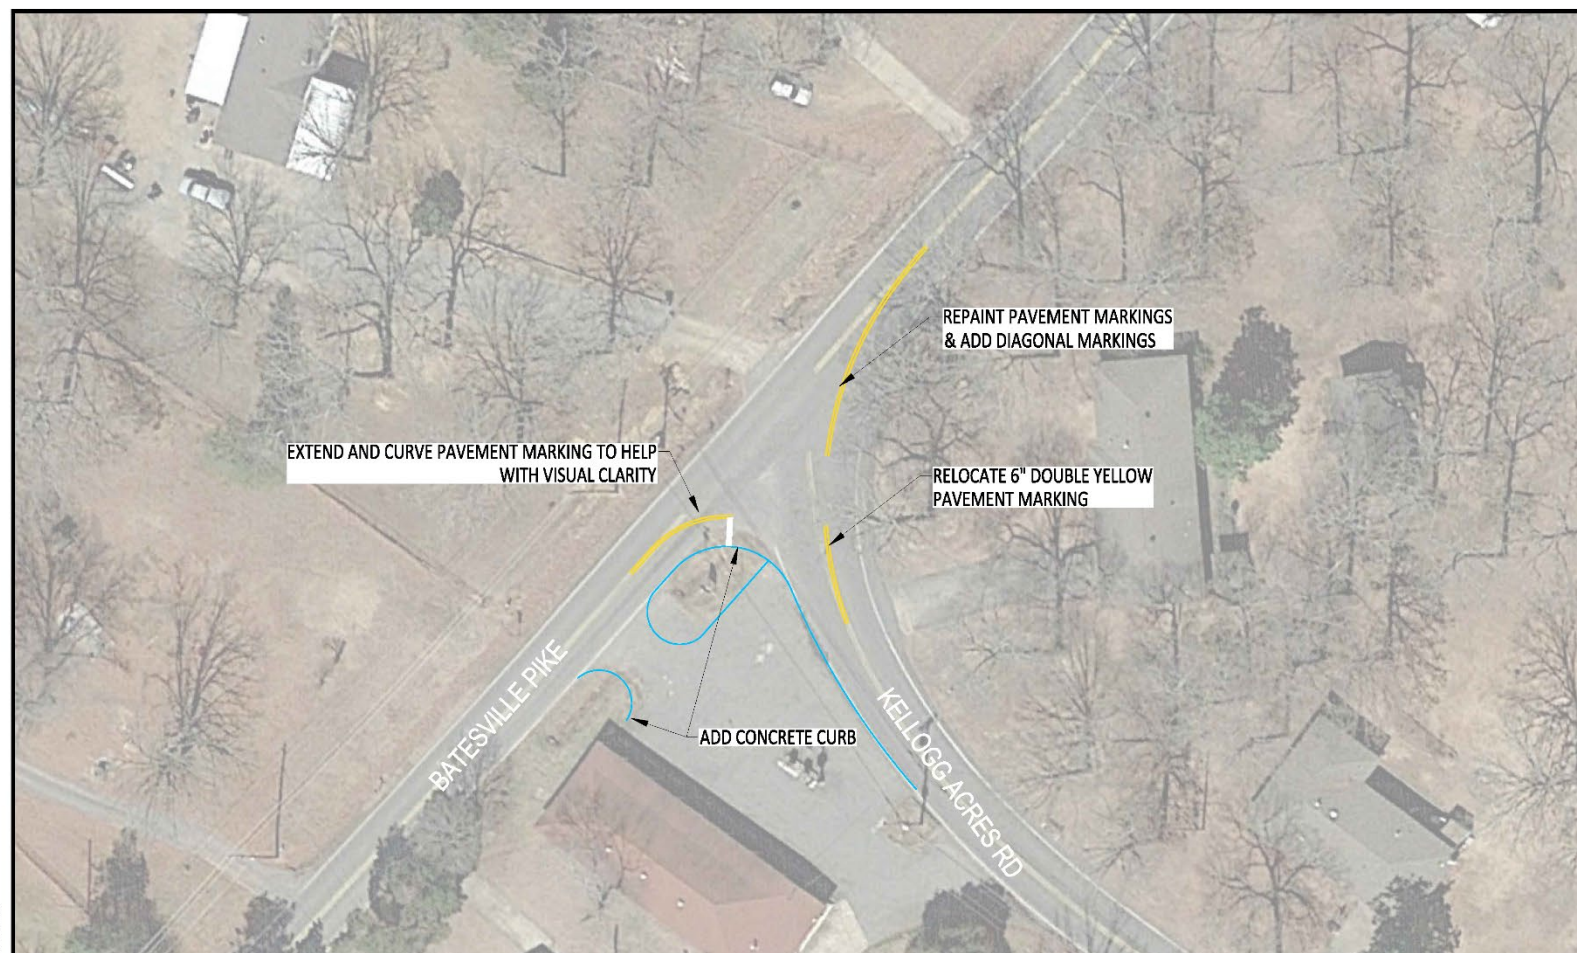
L5.03

**REPAINT PAVEMENT MARKINGS
& ADD DIAGONAL MARKINGS**

Conceptual Layout of the Short-Term Suggested Improvements at Batesville Pike and Kellogg Acres Road

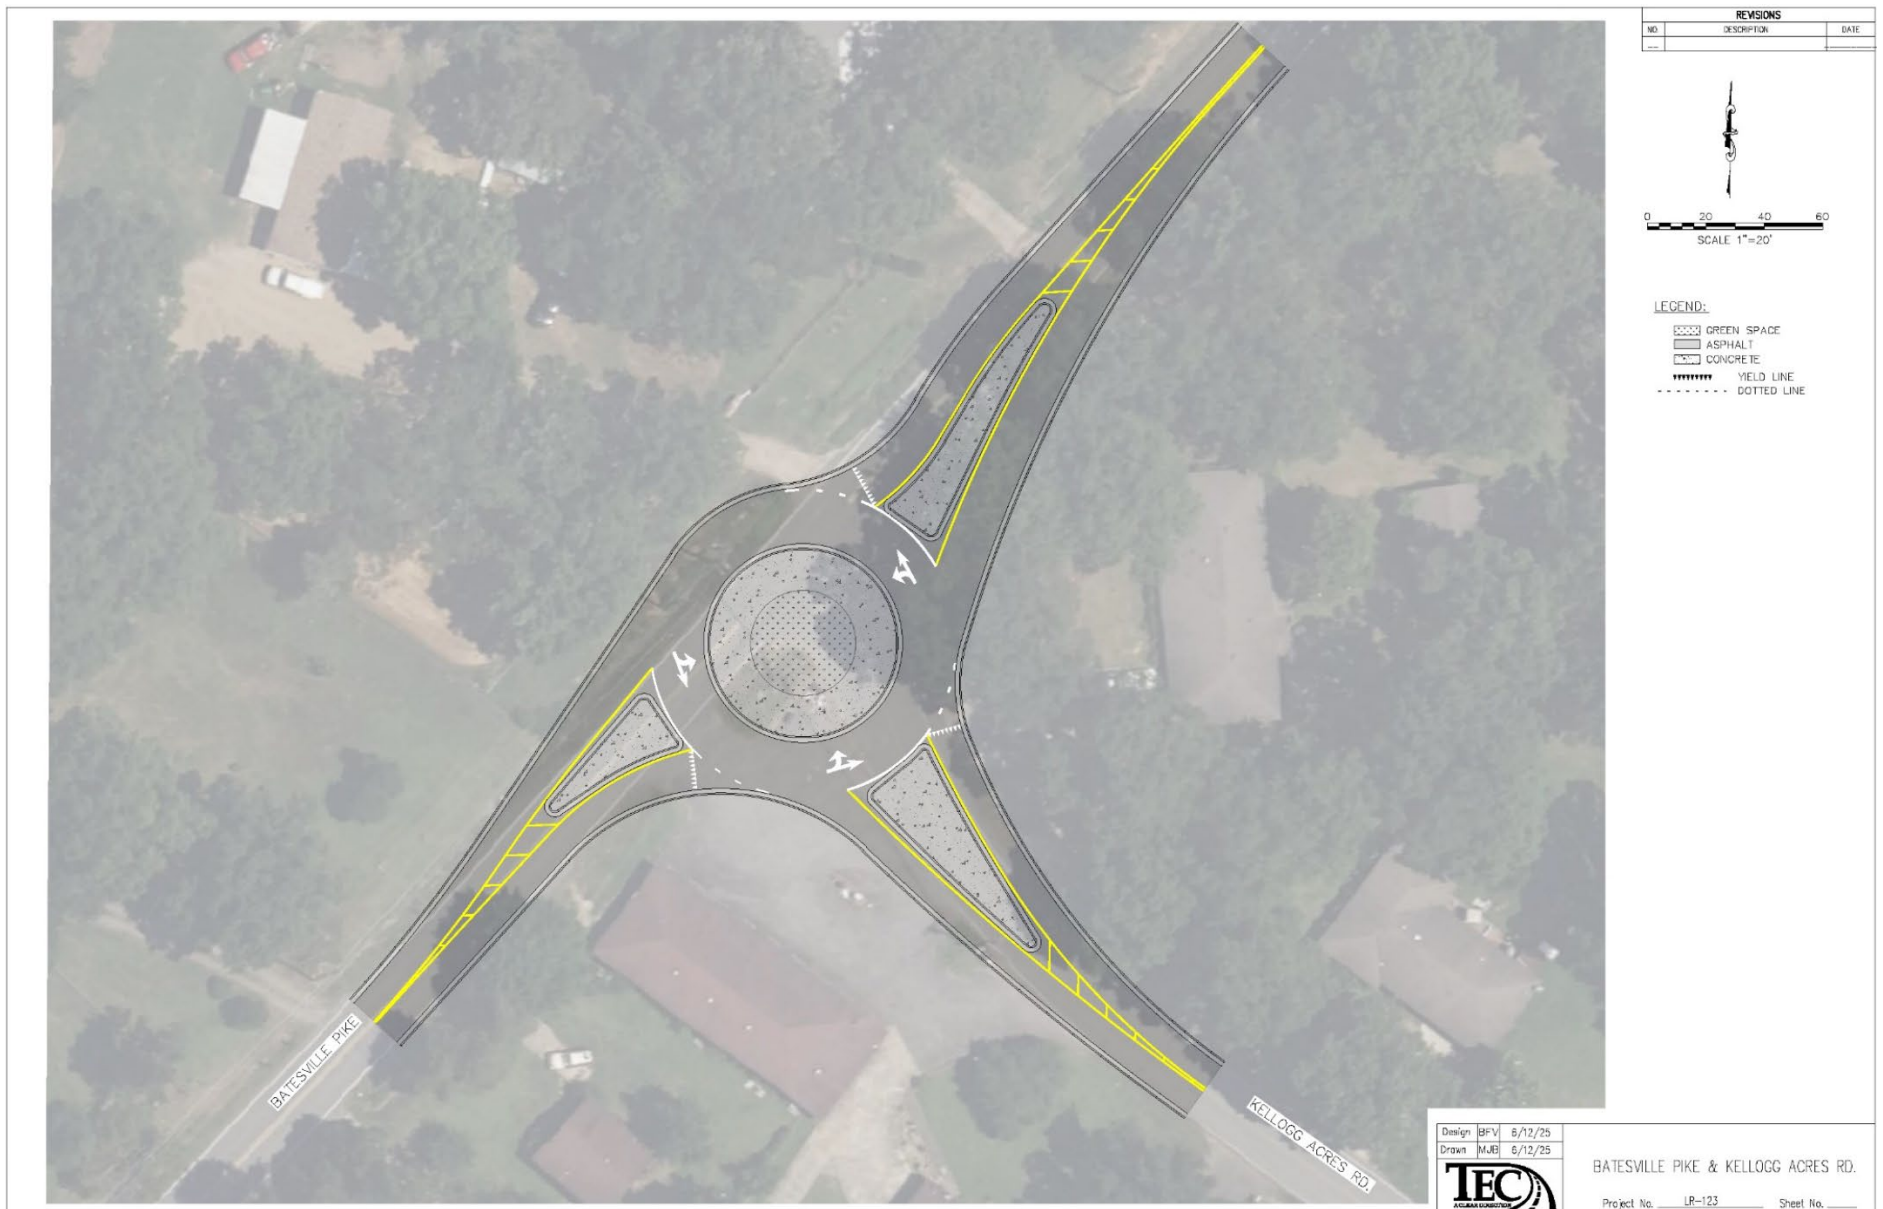
Conceptual Layout of the Mid-Term Suggested Improvements at Batesville Pike and Kellogg Acres Road
