SOUTH DONAGHEY AVENUE ROAD SAFETY AUDIT FINDINGS REPORT

July 2025

FINAL REPORT

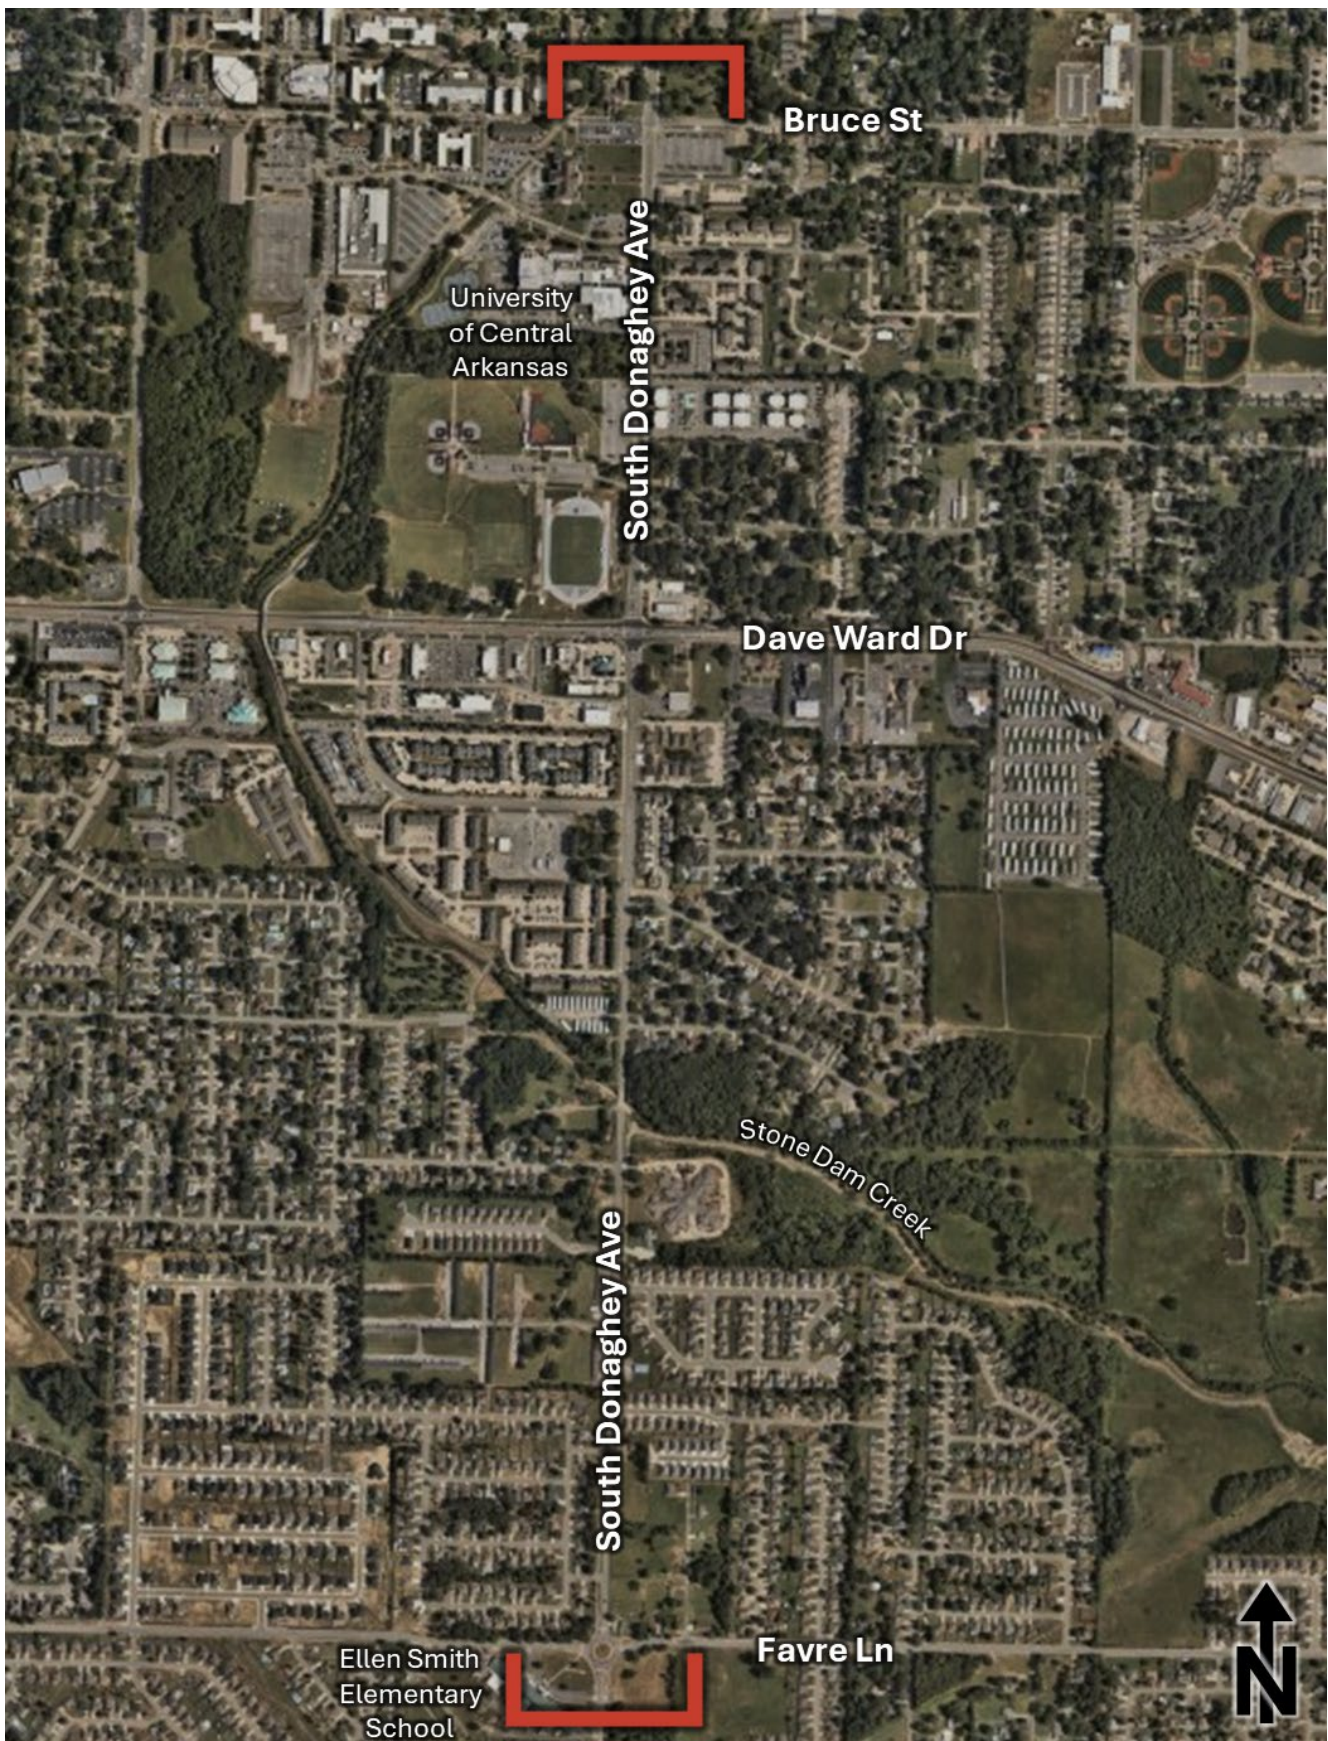
Figure 2: South Donaghey Avenue Study Corridor Extents

Between Bruce Street and Dave Ward Drive, South Donaghey Avenue consists of three lanes, with one lane in each direction separated by a two-way left-turn lane. Between Dave Ward Drive and Woodland Springs Drive, South Donaghey Avenue consists of five lanes, with two lanes in each direction and a center two-way left-turn lane. Between Woodland Springs Drive and Favre Lane, South Donaghey Avenue consists of two lanes, with one lane in each direction and no two-way left-turn lane. The study corridor has a posted speed limit of 30 miles per hour (mph) between Bruce Street and Dave Ward Drive and 40 mph between Dave Ward Drive and Favre Lane. A school zone with a reduced speed limit of 20 mph exists between Attwood Drive and Morning Glory Lane.

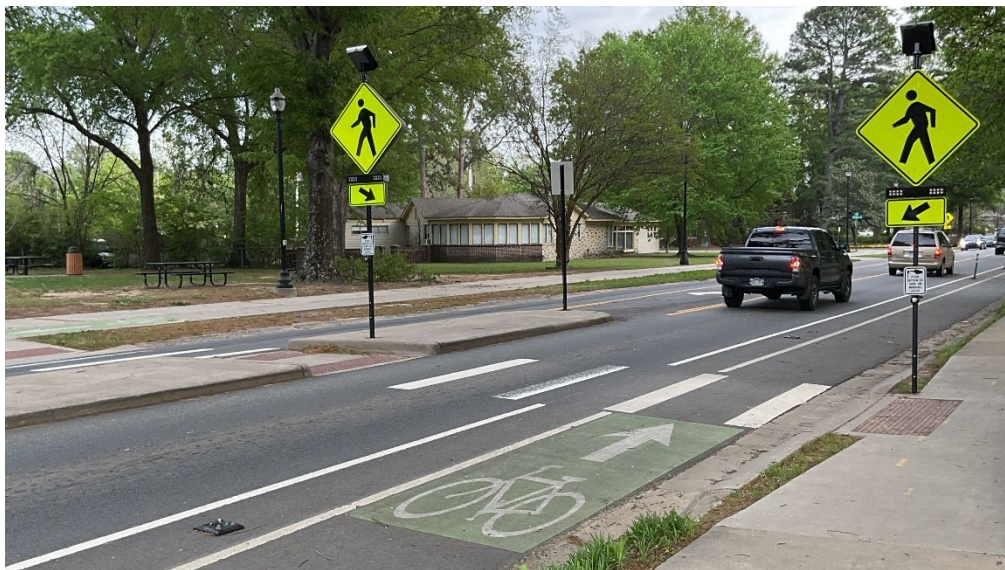
Figure 3: Rectangular Rapid Flashing Beacon

South Donaghey Avenue, along the University of Central Arkansas campus between Bruce Street and Dave Ward Drive, has three crossings with rectangular rapid flashing beacons (RRFBs) to alert drivers of pedestrians crossing South Donaghey Avenue midblock. Two of these RRFBs include raised concrete pedestrian refuge islands, one of which is shown in **Figure 3**, to provide pedestrians with a protected landing to wait for vehicles to stop in case the drivers on the opposite side do not see the crossing pedestrian. Providing high visibility crossing infrastructure is essential for safety in high pedestrian areas.

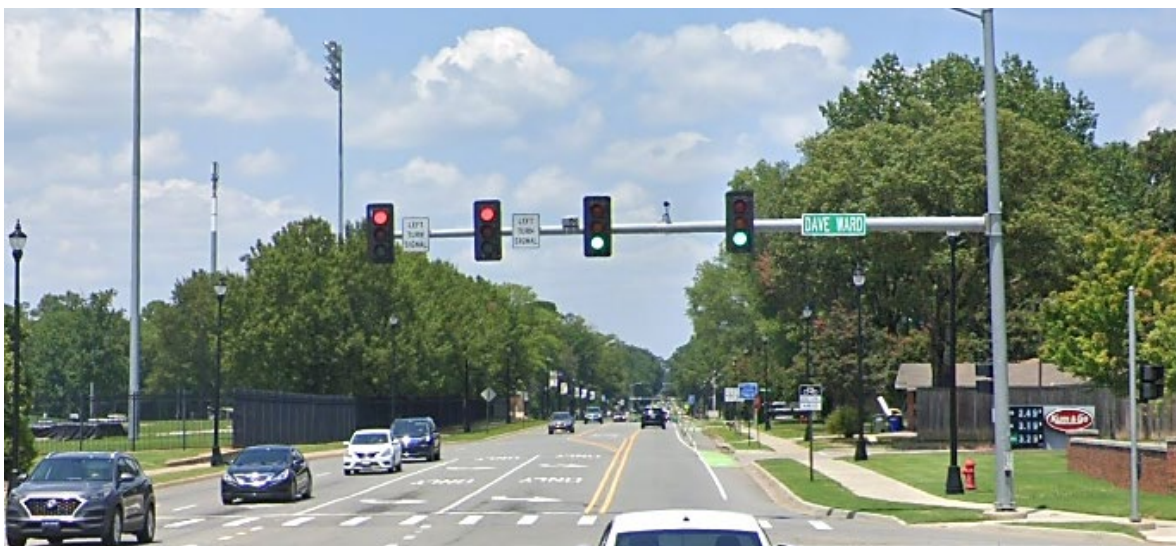
Figure 4: Trees and Lamp Posts

The existing tall trees and lamp posts along both sides of South Donaghey Avenue on the University of Central Arkansas campus between Bruce Street and Dave Ward Drive, as shown in **Figure 4**, alert drivers to a change in their surroundings and create a visual narrowing effect, subconsciously encouraging drivers to reduce their speed. This perceived narrowing of the road heightens driver awareness and caution, leading to more controlled and safer driving behaviors. Additionally, the aesthetic appeal of tree-lined and well-lit streets contributes to a calmer and more pleasant driving environment, further promoting cautious and responsible driving both during the day and at night.

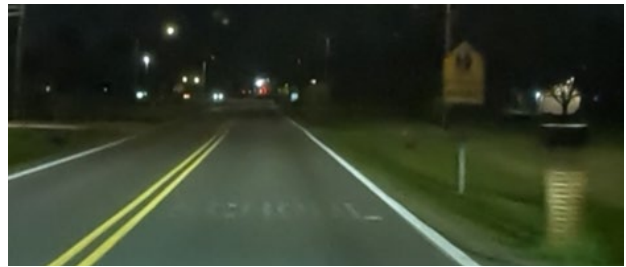
Figure 5: Northbound approach to the school zone warning sign at Favre Lane is not retroreflective and the SCHOOL pavement marking is faded.

- Replace all existing signs and object markers on South Donaghey Avenue that are not retroreflective with signs that meet the MUTCD retroreflectivity requirements.

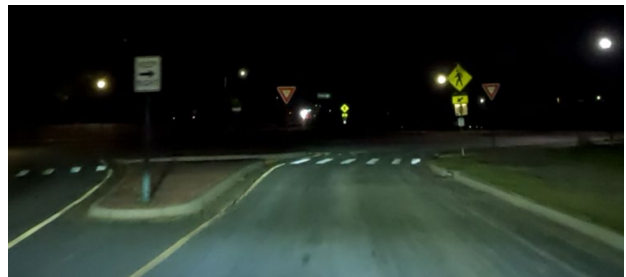
Figure 6: The keep right sign, yield signs, and one way arrow sign at the northbound approach to the roundabout at South Donaghey Avenue and Favre Lane are not retroreflective.

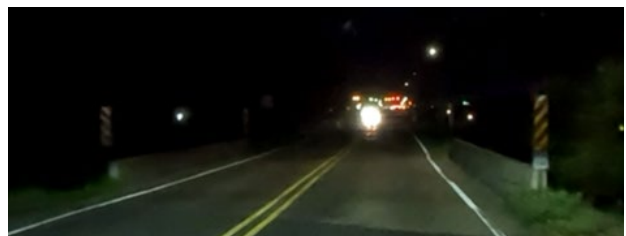
Figure 7: Object markers on both sides of the northbound approach to Stone Dam Creek bridge on South Donaghey Avenue are not retroreflective.

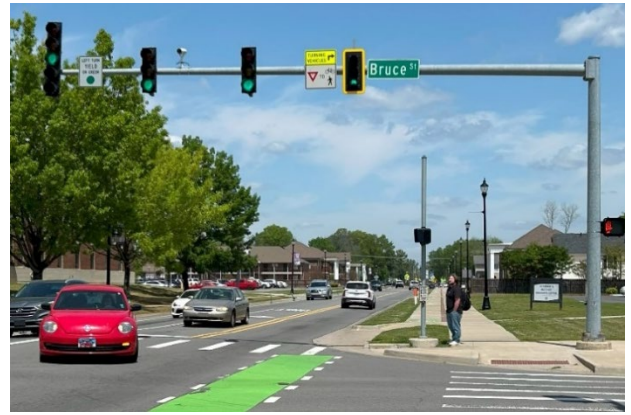
- Retroreflective yellow backplates are installed on traffic signal heads for the bike lanes, but not on most other traffic signal heads.
- The City noted they have been installing retroreflective backplates on all other traffic signal heads in the City when constructing a new signal or reconstructing an existing signal and are open to adding retroreflective backplates along the South Donaghey Avenue corridor.

Figure 8: Traffic signal heads for the northbound approach of South Donaghey Avenue to Bruce Street.

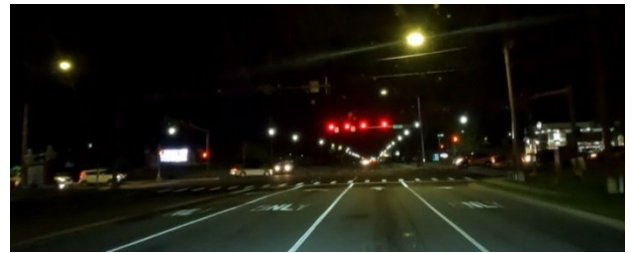
Figure 9: Northbound approach of South Donaghey Avenue to Dave Ward Drive.

Note: The cost estimate assumes upgrades or addition of lighting at up to three intersections. Intersection lighting at the intersection of South Donaghey Avenue and Dave Ward Drive is specifically addressed in suggested improvement number 16.

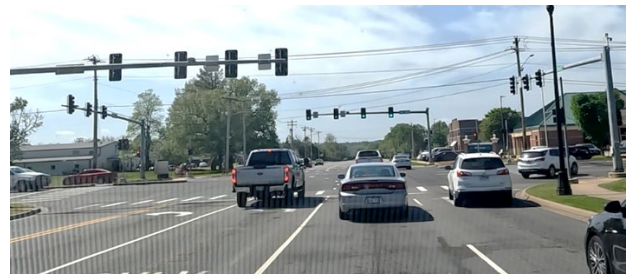
- The City Conway and Ellen Smith Elementary representatives expressed concern regarding speeding along South Donaghey Avenue. Potential causes of speeding noted by the representatives include the flat and straight nature of the corridor, long distance between signals/roundabouts south of Dave Ward Drive, and possible driver frustration with series of RRFBs near the University of Central Arkansas.

Figure 10: Southbound approach of South Donaghey Avenue to Dave Ward Drive has wide lanes leading to a wide intersection.

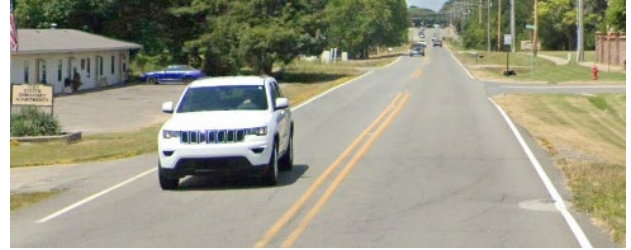
Figure 11: Northbound approach of South Donaghey Avenue to Massee Gardens is flat and straight with wide lanes.

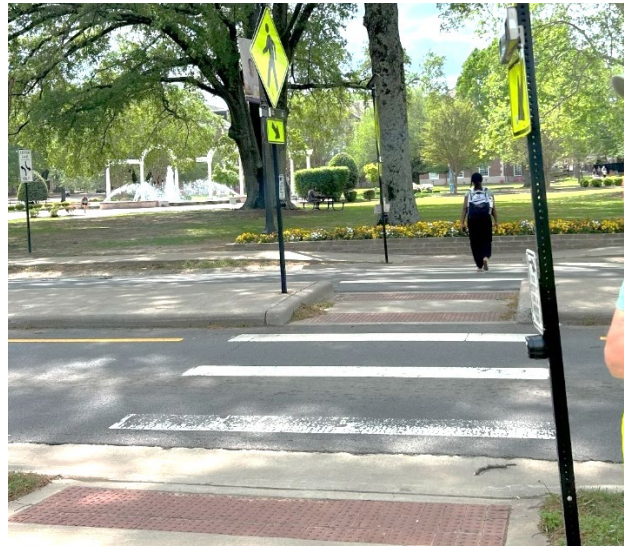
- Several pedestrians were observed pushing the RRFB buttons near the University of Central Arkansas and crossing without looking up to check that cars have stopped. This was especially common with students looking at smartphones.
- Some pedestrians were observed checking that the closest lane of traffic had stopped before stepping into the road, but did not check the other lanes or other direction of vehicular traffic once they began crossing.
- Some pedestrians at the RRFB crossings were observed crossing without pushing the button to activate the RRFB.

Figure 12: Student observed wearing headphones and crossing South Donaghey Avenue without pushing the button to activate the flashers at an RRFB near the University of Central Arkansas.

Note: The cost estimate assumes addition of sidewalk stickers or markings at three RRFB crossings.

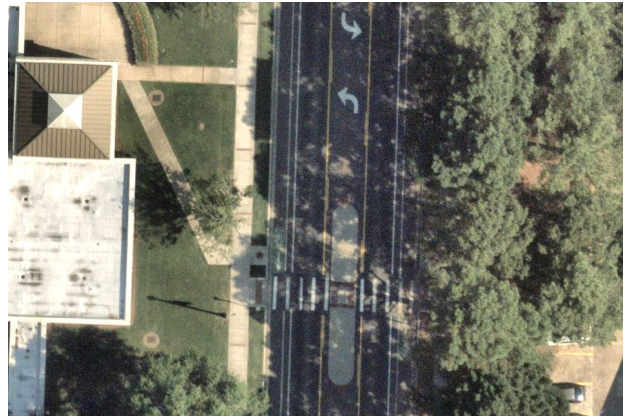
- Several sidewalks on campus or along streets that intersect South Donaghey Avenue across from the University of Central Arkansas direct students to cross at locations without marked or protected crossings.
- Pedestrians were observed crossing where the sidewalks from campus buildings meet South Donaghey Avenue even if there was not a marked or protected crossing.
- Many of the sidewalks on campus lead to marked crosswalks, so students may be used to crossing a road directly from where a sidewalk meets the road.

Figure 14: Sidewalks connecting the University of Central Arkansas PBS building to the sidewalk along the west side of South Donaghey Avenue do not align with the RRFB crossing.

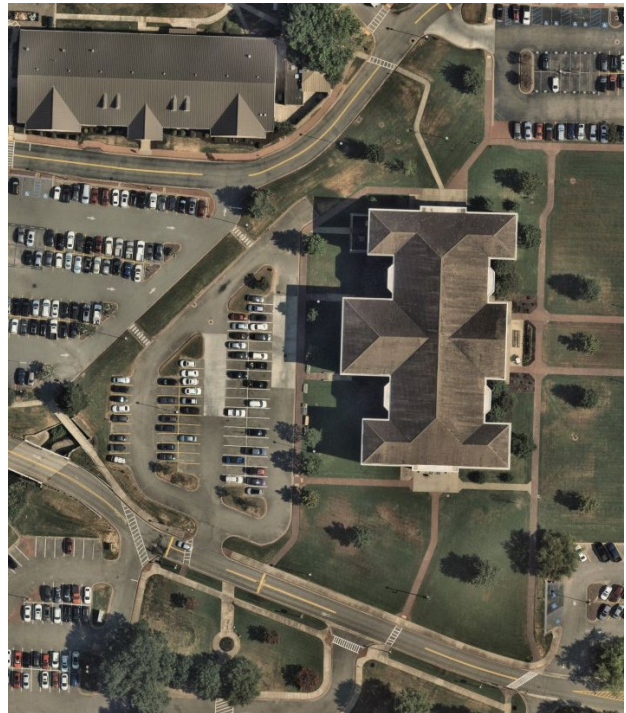
Figure 15: Many sidewalks on the University of Central Arkansas campus appear to lead to marked crosswalks.

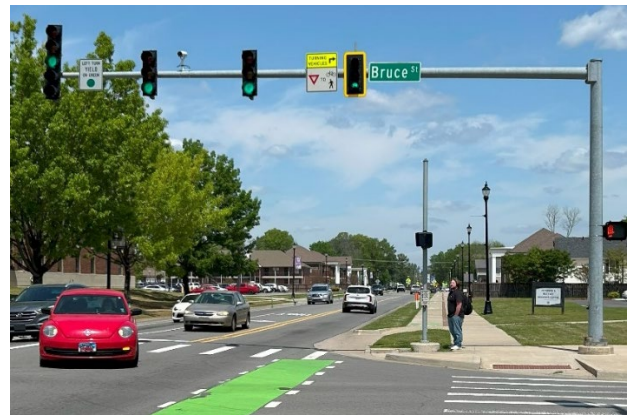
Figure 16: Traffic signal heads for the northbound approach of South Donaghey Avenue to Bruce Street.

- Replace existing left-turn traffic signal heads with flashing yellow arrow left-turn signal heads.

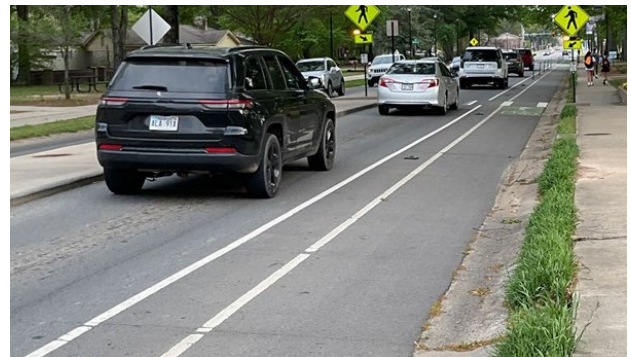
- Some delineators for the bike lane along the west side of South Donaghey Avenue are missing. For example, several are missing near RRFB between Bruce Street and Alumni Circle.
- University of Central Arkansas has an agreement with the City of Conway to maintain the bike lane along the west side of South Donaghey Avenue, but the City often gets complaints about debris in the bike lane which the City sweeper machines cannot access due to the delineators.
- City of Conway staff mentioned considering replacing the existing flex post delineators with something similar to raised pavement markers for easier maintenance.
- The RSA team observed bicyclists biking on the sidewalk along the west side of South Donaghey Avenue instead of using the bike lane.

Figure 17: Several delineators for the bike lane are missing along the west side of South Donaghey Avenue near the RRFB closest to Bruce Street.

- Replace the missing delineators for the bike lane along South Donaghey Avenue between Bruce Street and Dave Ward Drive.
- Encourage the University of Central Arkansas to maintain bike lanes which will promote use of the lanes and separation of bicyclists and pedestrians.

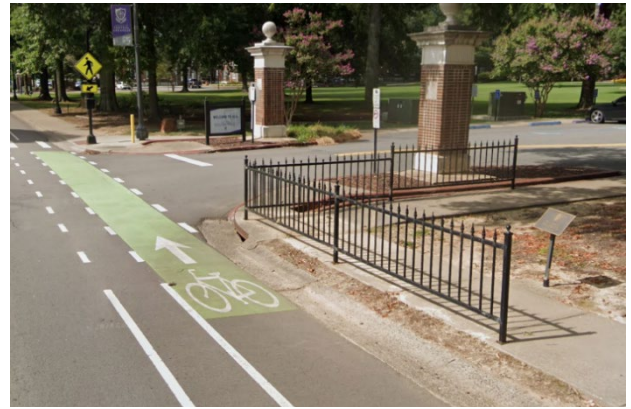
Figure 18: Fence at the northwest corner of South Donaghey Avenue and Alumni Circle/South Boulevard.

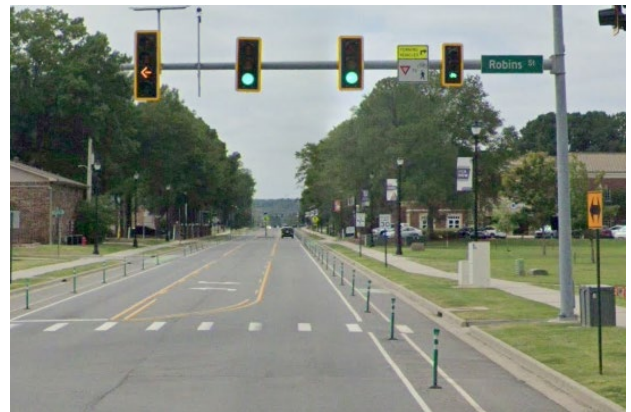
Figure 19: Traffic signals and signs for the southbound approach of South Donaghey Avenue to Robins Street.

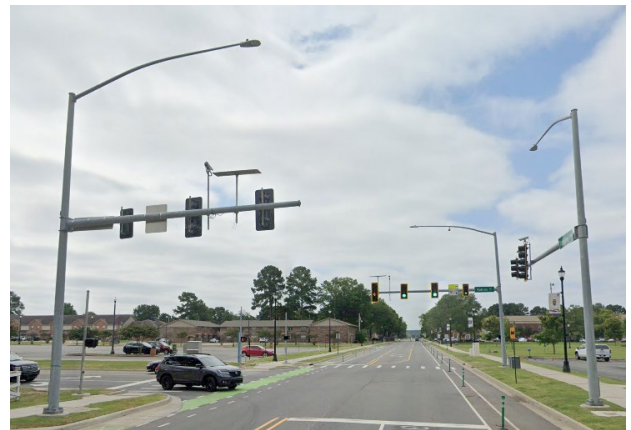
Figure 20: Existing intersection lighting on traffic signal poles at the South Donaghey Avenue and Robins Street intersection.

Note: Cost to be determined based on further investigation into the cause of the lighting not being operational.

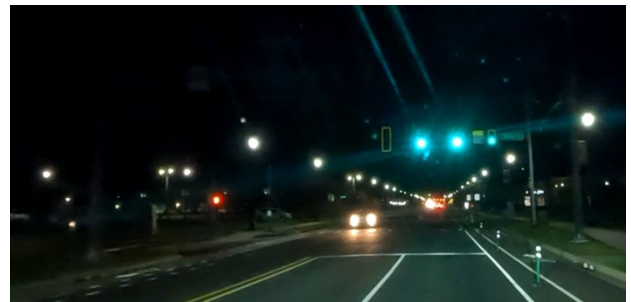
Figure 21: South Donaghey Avenue and Robins Street intersection at night.

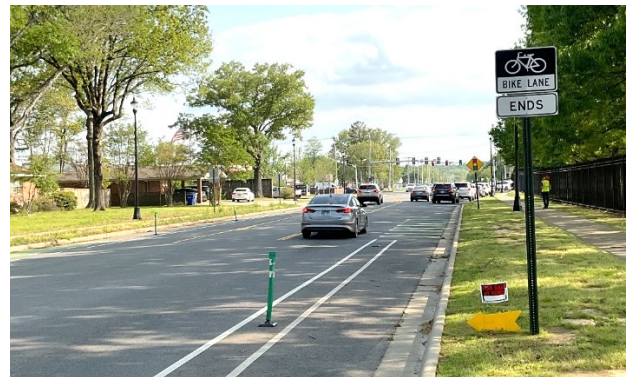
Figure 22: Bike lane ends signage at the southbound approach of South Donaghey Avenue to Dave Ward Drive.

*Note: A conceptual drawing of suggested improvements at South Donaghey Avenue and Dave Ward Drive, including the bike lane improvement, is included in **Appendix C**.*

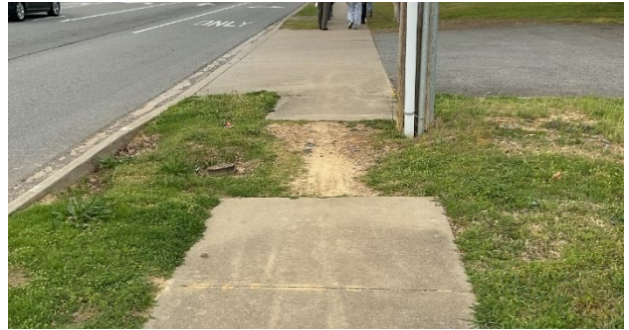
- A section of sidewalk is missing on the east side of South Donaghey Avenue at the northbound approach to Dave Ward Drive.
- A water line access cover in the middle of the sidewalk along Dave Ward Drive near the southeast corner is raised 1.75" above the surface of the sidewalk and is a tripping hazard.

Figure 23: Section of sidewalk is missing on the east side of South Donaghey Avenue south of Dave Ward Drive.

*Note: A conceptual drawing of the suggested improvements at South Donaghey Avenue and Dave Ward Drive, including the sidewalk water line location, is included in **Appendix C**.*

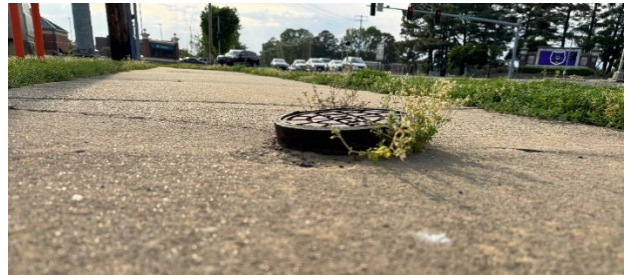
Figure 24: Water line access cover raised 1.75" above sidewalk surface near the southeast corner of South Donaghey Avenue and Dave Ward Drive.

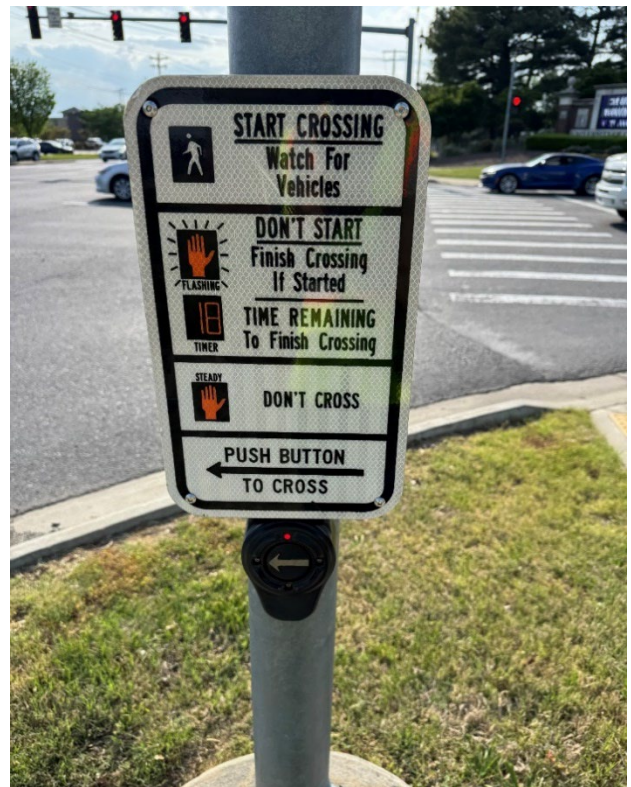
- Several pedestrian signal heads and accessible pedestrian signals (APS) at the intersection of South Donaghey Avenue and Dave Ward Drive appeared to be malfunctioning when tested in the field. The following issues were noted, but not every pedestrian signal head and APS was tested.
 - Orange hand on signal head for eastbound pedestrians at the north leg of the intersection was not flashing when counting down and the walk symbol did not come on.
 - Audio for the APS at the northwest corner was very quiet and difficult to hear over traffic noise.
 - Audio for the APS at the northeast corner was unclear.

Figure 25: The APS push button for the crossing Dave Ward Drive at the east leg of the intersection.

- Test and repair or replace all pedestrian signal heads and APS units.

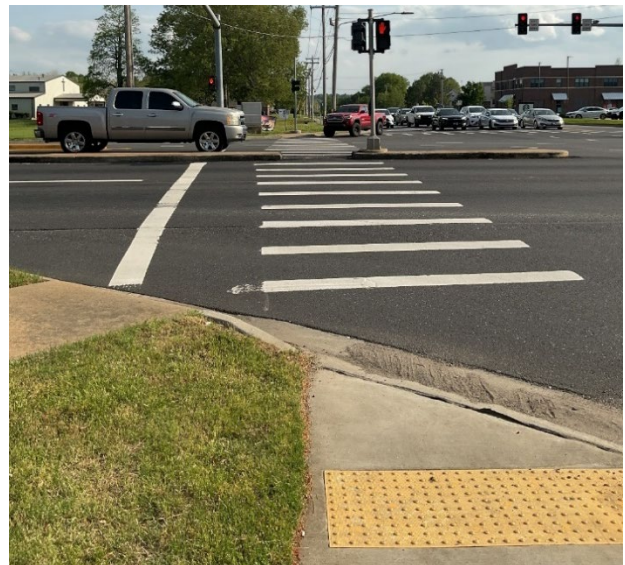
- RSA team members noted the pedestrian signal timing felt short when crossing all legs of the intersection and a do not cross message appears even when there seems to be time left for safe crossing. This may lead pedestrians to think they do not have sufficient time to cross and unnecessarily stop in the narrow refuge islands that exist for the Dave Ward Drive crossings to wait for the next cycle. City of Conway representatives noted that the pedestrian signal poles in the narrow refuge island regularly get hit by vehicles, so providing adequate pedestrian crossing time for pedestrians to fully cross the road is important.

Figure 26: Southbound pedestrian crossing for crossing Dave Ward Drive at the east leg of the intersection.

- Option 1: Reconstruct existing pedestrian refuge islands along Dave Ward Drive to be at least 6-feet wide to provide more buffer between pedestrians waiting on the refuge island and vehicles moving through the intersection.

- Option 2: Complete Option 1 and construct pedestrian refuge islands for crossing the South Donaghey Avenue approaches. The pedestrian islands would also provide an opportunity to narrow lanes and provide traffic calming for northbound vehicles on South Donaghey Avenue prior to entering onto the University of Central Arkansas campus.

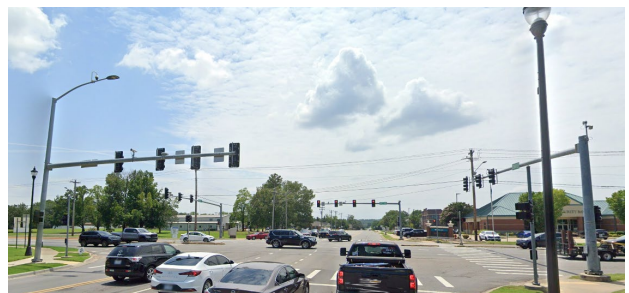
- Seven out of 15 fatal, suspected serious injury, and suspected minor injury crashes at the intersection of South Donaghey Avenue and Dave Ward Drive were reported as occurring in dark light conditions.
- Lighting exists along both approaches of South Donaghey Avenue to Dave Ward Drive, but trees cast shadows, and some lights seemed dim at night.
- Intersection lighting exists at the northeast, southeast, and southwest corners and is angled perpendicular to the approaches. The existing lights do not extend over the middle of the intersection and only cast light on the one or two lanes the light is directly over.

Figure 27: Intersection lighting exists at the northeast, southeast, and southwest corners of South Donaghey Avenue and Dave Ward Drive.

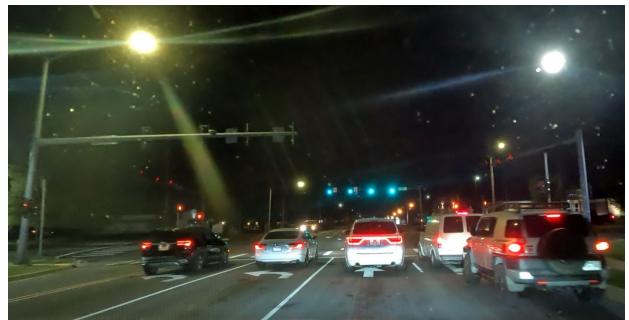
Figure 28: The existing intersection lighting does not illuminate the middle of the intersection or cast light over all lanes at all approaches.

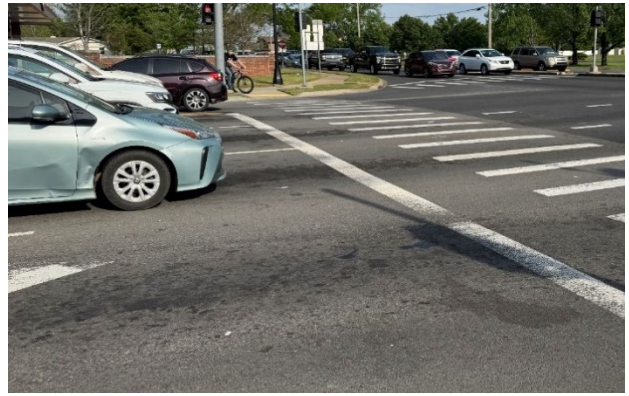
Figure 29: Visibility for right-turn vehicles at the southbound approach of South Donaghey Avenue to Dave Ward Drive is limited by a brick wall at the northeast corner of the intersection.

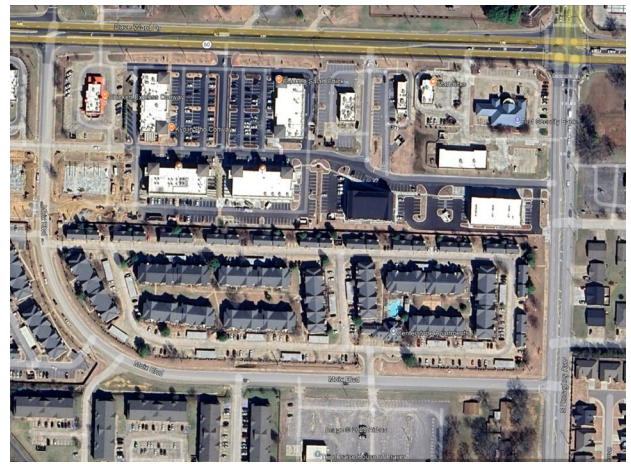
Figure 30: Aerial of the southwest corner block between South Donaghey Avenue, Dave Ward Drive, and Moix Boulevard.

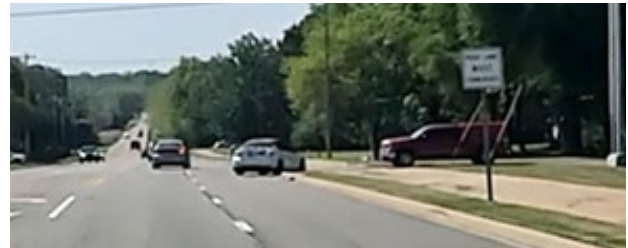
Figure 31: Right lane must turn right sign posted for southbound right-turn lane for University Park Apartments Driveway is posted in advance of Moix Boulevard, where cars were observed turning right.

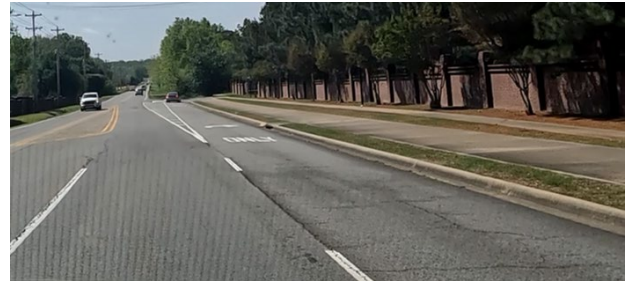
Figure 32: White dashed lane lines leading up to the southbound right-turn lane for the University Park Apartments Driveway.

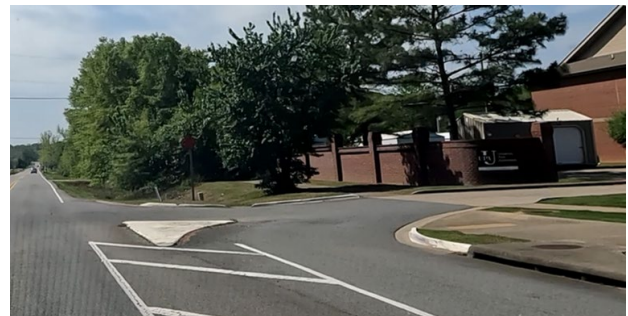
Figure 33: Raised concrete channelization island and pavement markings for the southbound right-turn lane along South Donaghey Avenue for the University Park Apartments Driveway.

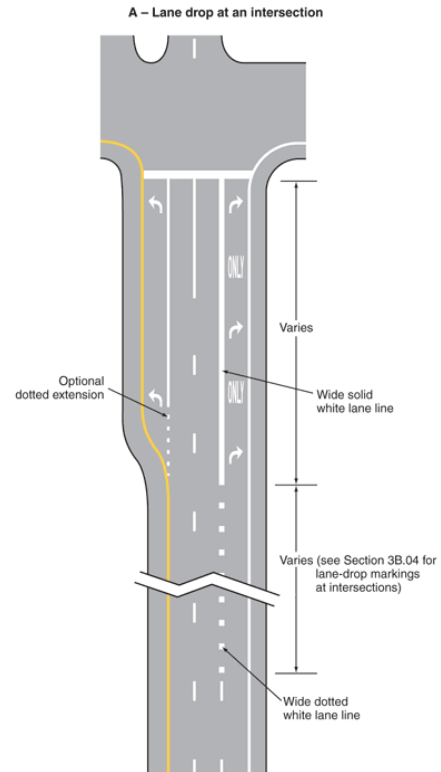
Figure 3B-11. Examples of Applications of Conventional Road Lane-Drop Markings
(Sheet 1 of 2)

Figure 34: Example turn lane striping.

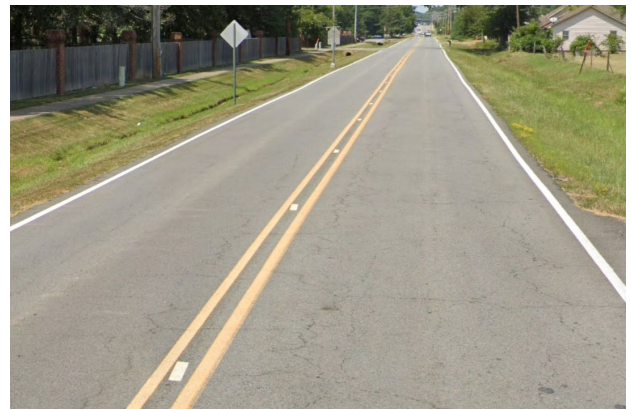
Figure 35: White dashed pavement marking along the centerline striping of South Donaghey Avenue near the northbound approach to Attwood Drive.

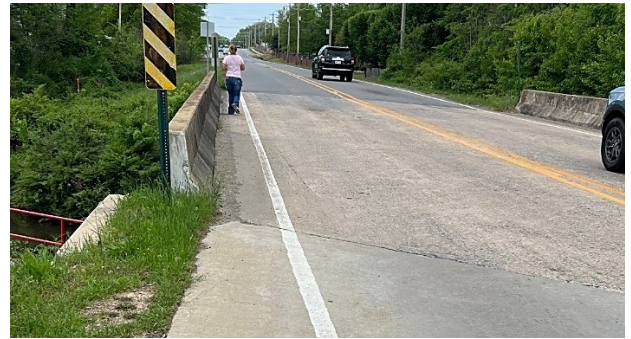
- The nearest greenway trail crossing for greenway users to get from the south side of Stone Dam Creek to the north side is approximately 0.2-miles west of South Donaghey Avenue.
- A pedestrian was observed crossing the bridge and City of Conway representatives noted they regularly see pedestrians crossing the bridge.
- A footpath was observed worn into the grass along the west side of South Donaghey Avenue south of the bridge, where no sidewalk is present.
- A pedestrian was observed walking along the west side of South Donaghey Avenue where there is a gap in the sidewalk near Sugar Creek Drive.

Figure 36: Pedestrian crossing Stone Dam Creek bridge in the narrow shoulder.

- Create a pedestrian and bicyclist crossing along the west side of the bridge. This could be a cantilever type bridge added to the existing bridge, or a bridge added adjacent to the existing bridge. Additional study of the bridge is needed.
- Construct sidewalk along the west side of South Donaghey Avenue to fill in the missing sidewalk gap.

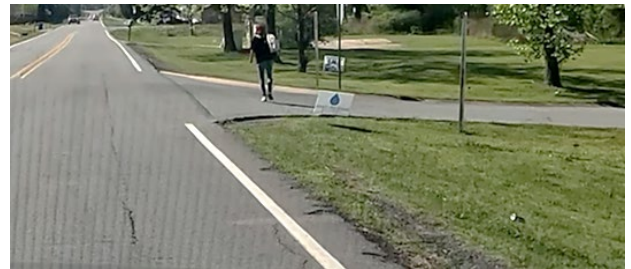
Figure 37: Pedestrian observed walking along the west side of South Donaghey Avenue where there is a gap in the sidewalk near Sugar Creek Drive.

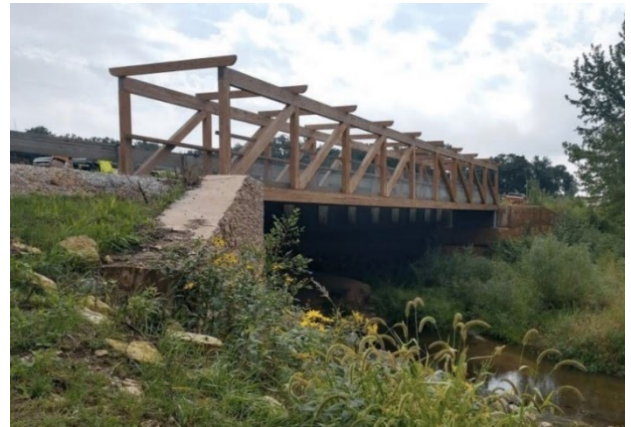
Figure 38: Example of a pedestrian bridge added to an existing bridge in Buchanan County, Iowa. (Photo courtesy of Buchanan County)

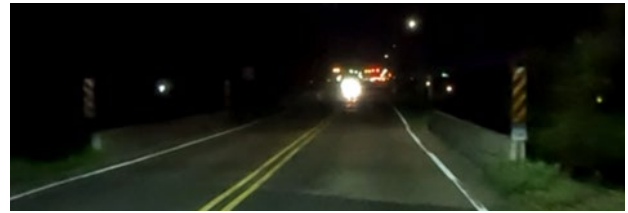
- Reflectors do not exist along the bridge walls of Stone Dam Creek Bridge on South Donaghey Avenue.
- A small shoulder buffer is present between the edge line and bridge walls.
- Street lighting was observed to be very dim along the bridge.

Figure 39: Reflectors do not exist along the bridge walls of Stone Dam Creek Bridge.

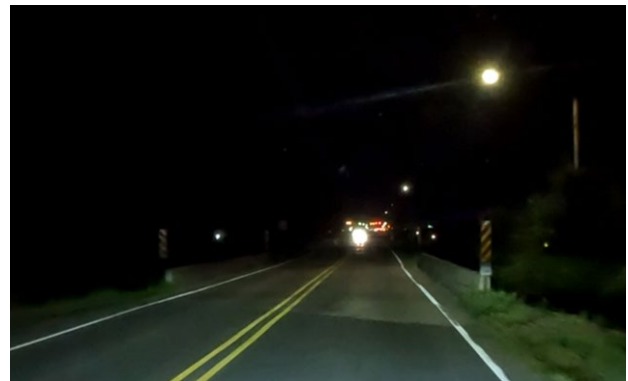
- Lighting exists consistently along the west side of South Donaghey Avenue. Some lighting also exists along the east side, but all existing corridor lighting is very dim, set back from roadway, and very spaced out between Stone Dam Creek Bridge and Favre Lane.
- Concern was expressed by the Principal of Ellen Smith Elementary regarding students walking to the school in the dark.
- Pedestrians were observed by the RSA team walking at night along the northbound edge line of South Donaghey Avenue near Attwood Drive, where the corridor lighting is very spaced out and the road is very dark.

Figure 40: The existing streetlight at the Stone Creek Dam bridge is very dim.

- Replace existing corridor lighting with lighting that provides more illumination, particularly within the school zone at the northbound and southbound approaches to Favre Lane.

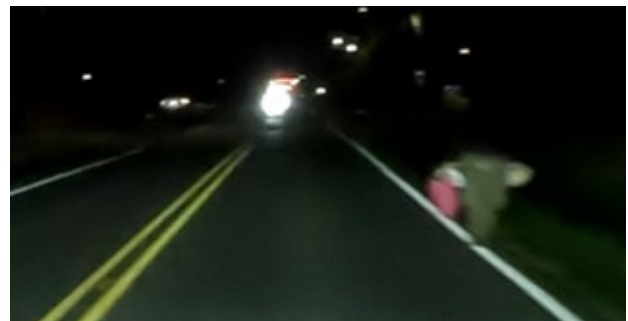
Figure 41: Pedestrian walking on the northbound edge line of South Donaghey Avenue at night near Attwood Drive, where the corridor lighting is very spaced out and the road is very dark.

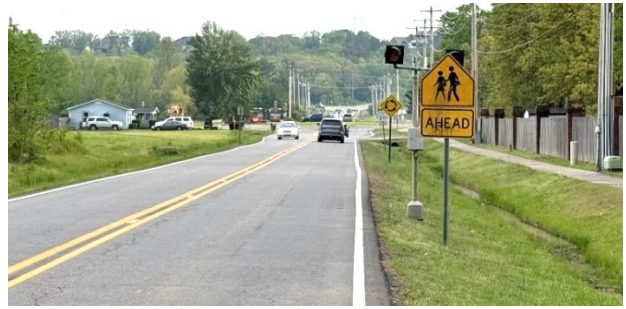
- The Principal of Ellen Springs Elementary noted concern about school zone signage spacing.
- At the northbound approach of South Donaghey Avenue to Favre Lane, the school zone ahead sign is 364-feet from the flashing beacon, the flashing beacon is 308-feet to the school fence, and the school fence is 210-feet to the exit driveway.
- At the southbound approach of South Donaghey Avenue to Favre Lane, the school zone ahead sign is 15-feet to the flashing beacon, the flashing beacon is 288-feet to the school zone speed limit sign, and the school zone speed limit sign is 556-feet to the school sidewalk.
- School zone ahead sign for southbound vehicles blocks visibility of the flashing beacons.
- The school zone is not consistently signed in both directions of South Donaghey Avenue.

Figure 42: The school zone ahead warning sign on southbound South Donaghey Avenue blocks the view of the flashing beacons for southbound vehicles approaching Favre Lane.
